## Tuddenham Village Council

Inspection Ref: 2282700

Operational Inspection - 2-February-2024 - 13:24 Inspector Philip Smith

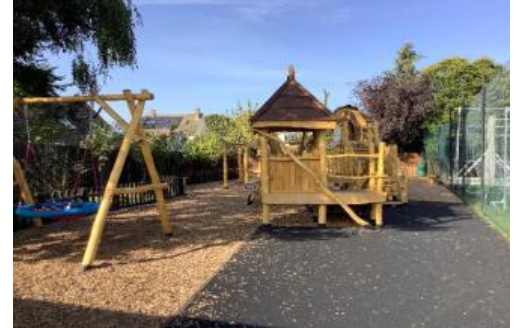
**Item:** Site General  
**Manufacturer:** Owner/Operator  
**Surface Type:** N/A  
**Item Quantity:** 1  
**Equipment Compliance:** N/A  
**Surface Area Compliance:** N/A

This item is satisfactory - no work required -

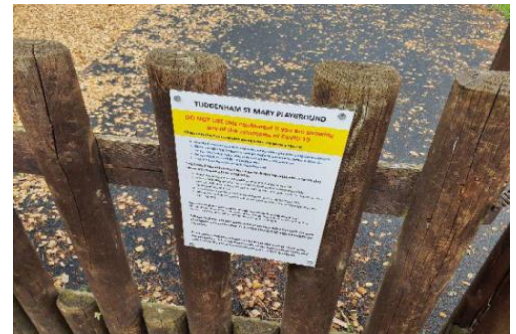
**Item:** Sign  
**Manufacturer:** Owner/Operator  
**Surface Type:** N/A  
**Item Quantity:** 1  
**Equipment Compliance:** N/A  
**Surface Area Compliance:** N/A

It is recommended that information signs with emergency contact details are installed at each entrance/exit point to the playground - Provide in accordance with the recommendations set out in BS EN 1176

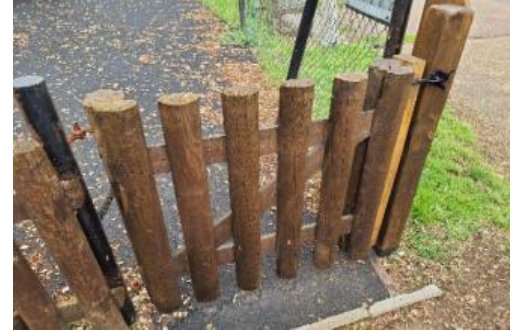
**Item:** Gate  
**Manufacturer:** Not Identified  
**Surface Type:** Wet Pour  
**Item Part Number:**  
**Item Quantity:** 1  
**Equipment Compliance:** N/A  
**Surface Area Compliance:** N/A  
**Total Findings:** 1

This item is satisfactory - no work required -

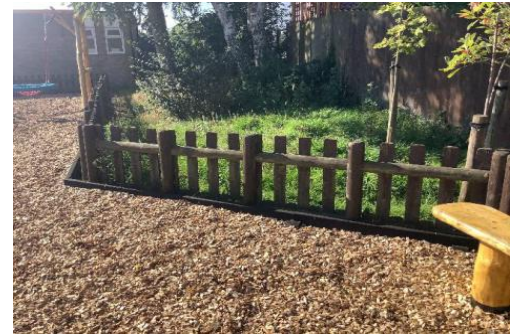
**Item:** Fencing - Timber  
**Manufacturer:** Not Identified  
**Surface Type:** Mixed Surface  
**Item Quantity:** 1  
**Equipment Compliance:** N/A  
**Surface Area Compliance:** N/A  
**Total Findings:** 2

The timber has a number of splits/shakes or air cracks and this may affect the stability or allow water ingress which will accelerate the rotting process - Monitor to ensure the splits do not cross through fixing points of the structure and/or cause any instability

There are a number of loose posts around the fence - Monitor for any further deterioration and reset as required

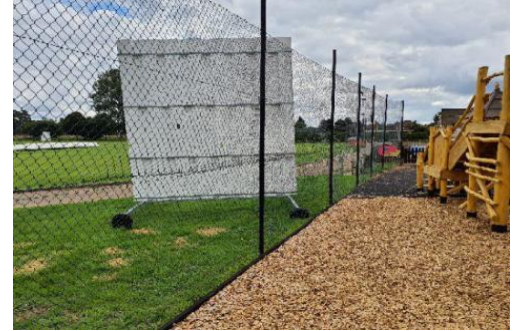
**Item:** Fence - Chainlink  
**Manufacturer:** Not Identified  
**Surface Type:** Woodchip  
**Item Quantity:** 1  
**Equipment Compliance:** N/A  
**Surface Area Compliance:** N/A

The adjacent foliage is overhanging or growing through the fence - Cut back and maintain

The fence is damaged in places - Repair or replace all affected sections

The paintwork on this item has been damaged or worn exposing the metal underneath which is rusting - Treat any rusting components and repaint

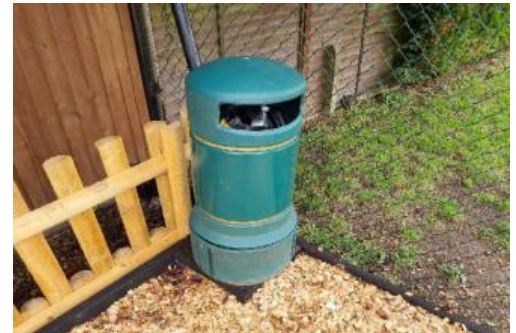
**Item:** Litter Bin  
**Manufacturer:** Not Identified  
**Surface Type:** Woodchip  
**Item Quantity:** 1  
**Equipment Compliance:** N/A  
**Surface Area Compliance:** N/A

This item is satisfactory - no work required -

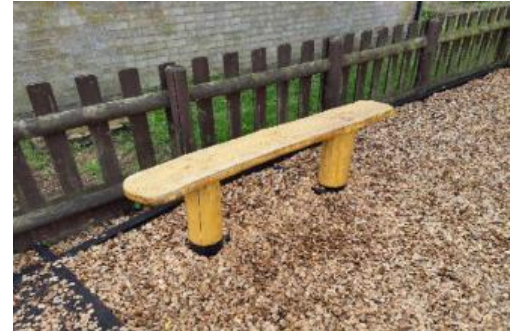
**Item:** Bench  
**Manufacturer:** Not Identified  
**Surface Type:** Bark Mulch  
**Item Quantity:** 2  
**Equipment Compliance:** N/A  
**Surface Area Compliance:** N/A

This item is satisfactory - no work required -

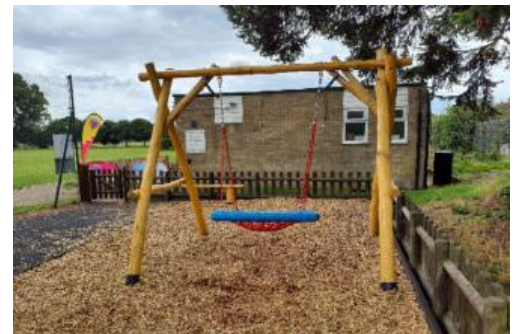
**Item:** Basket Swing - Type 1  
**Manufacturer:** Not Identified  
**Surface Type:** Woodchip  
**Item Quantity:** 1  
**Equipment Compliance:** No  
**Surface Area Compliance:** Yes

This item is satisfactory - no work required -

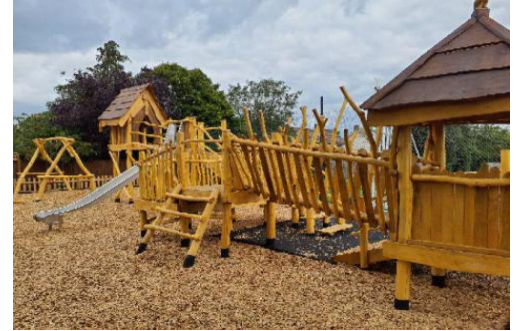
**Item:** Multi Play (Senior)  
**Manufacturer:** Not Identified  
**Surface Type:** Mixed Surface  
**Item Quantity:** 1  
**Equipment Compliance:** No  
**Surface Area Compliance:** Yes

The timber has a number of splits/shakes or air cracks and this may affect the stability or allow water ingress which will accelerate the rotting process - Monitor to ensure the splits do not cross through fixing points of the structure and/or cause any instability

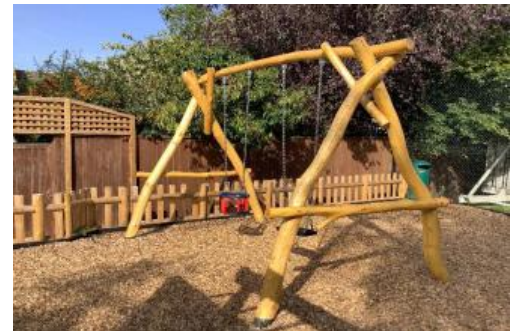
**Item:** 1 Bay Mixed Seat, 1 Cradle, 1 Flat  
**Manufacturer:** Not Identified  
**Surface Type:** Woodchip  
**Item Quantity:** 1  
**Equipment Compliance:** Yes  
**Surface Area Compliance:** Yes

This item is satisfactory - no work required -

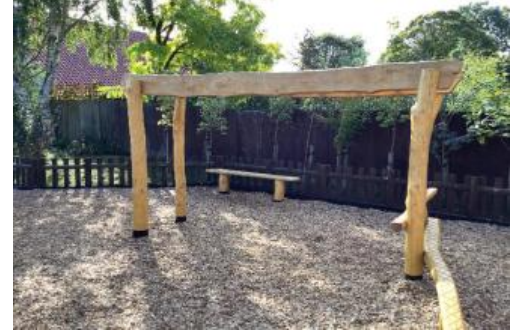
**Item:** Monkey Bars  
**Manufacturer:** Not Identified  
**Surface Type:** Woodchip  
**Item Quantity:** 1  
**Equipment Compliance:** Yes  
**Surface Area Compliance:** Yes

This item is satisfactory - no work required -

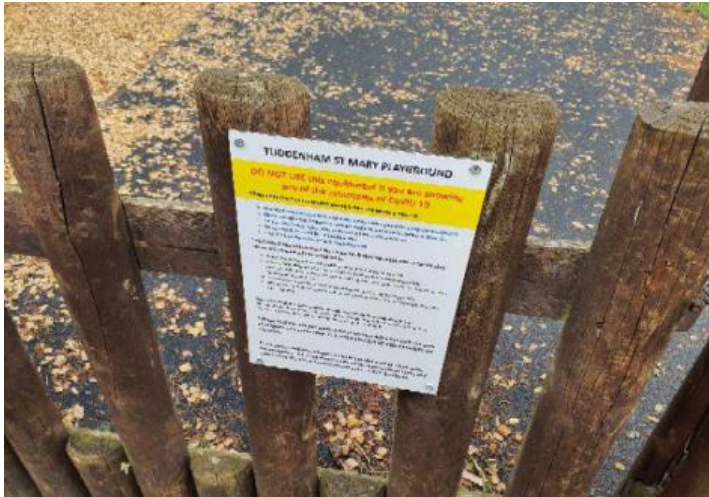
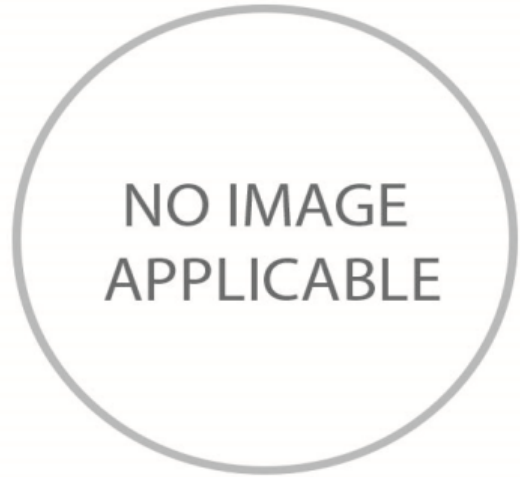
**Item:** Ancillary Items - Sign  
**Manufacturer:** Owner/Operator

**Finding:** It is recommended that information signs with emergency contact details are installed at each entrance/exit set out in BS EN 1176 point to the playground  
**Action:** Provide in accordance with the recommendations

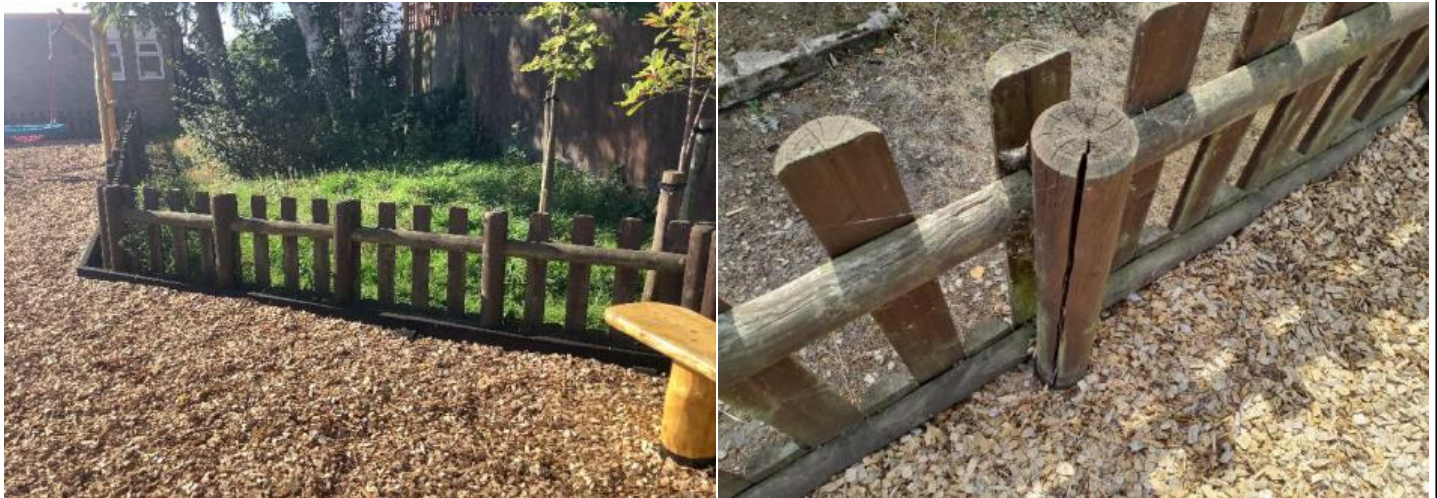
**Item:** Fences - Fencing - Timber  
**Manufacturer:** Not Identified

**Finding:** The timber has a number of splits/shakes or air cracks and this may affect the stability or allow water ingress which will accelerate the rotting process  
**Action:** Monitor to ensure the splits do not cross through fixing points of the structure and/or cause any instability

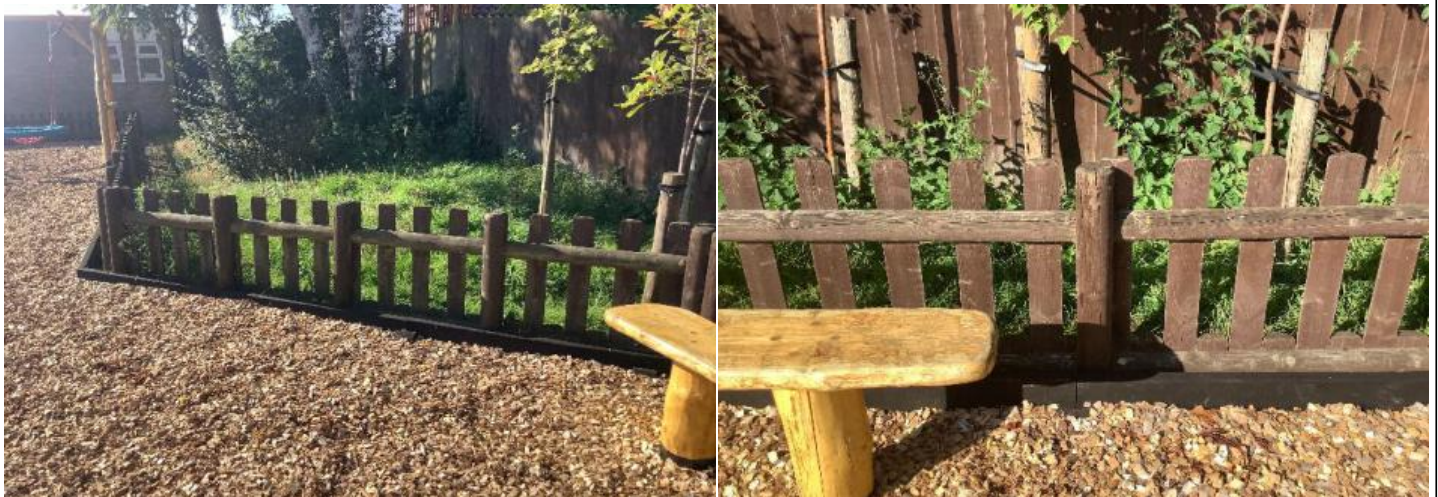
**Item:** Fences - Fencing - Timber  
**Manufacturer:** Not Identified

**Finding:** There are a number of loose posts around the fence  
**Action:** Monitor for any further deterioration and reset as required

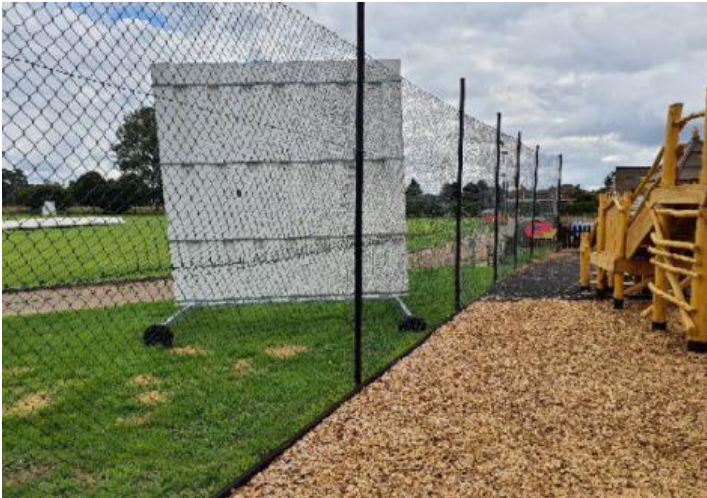
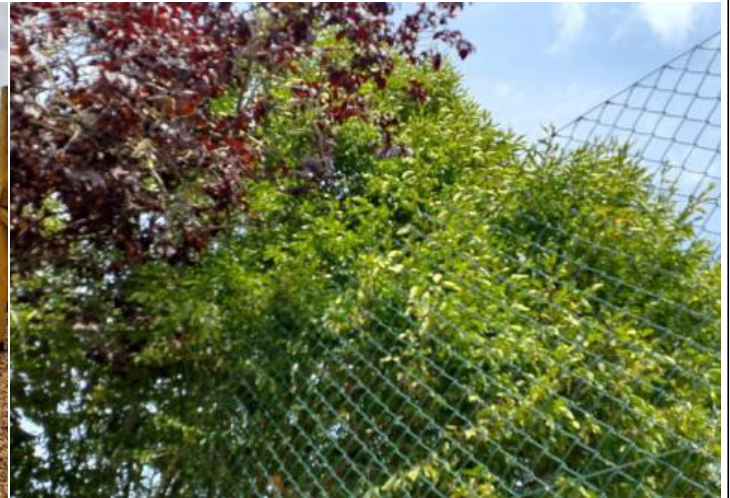
**Item:** Fences - Fence - Chainlink  
**Manufacturer:** Not Identified

**Finding:** The adjacent foliage is overhanging or growing through the fence

**Action:** Cut back and maintain

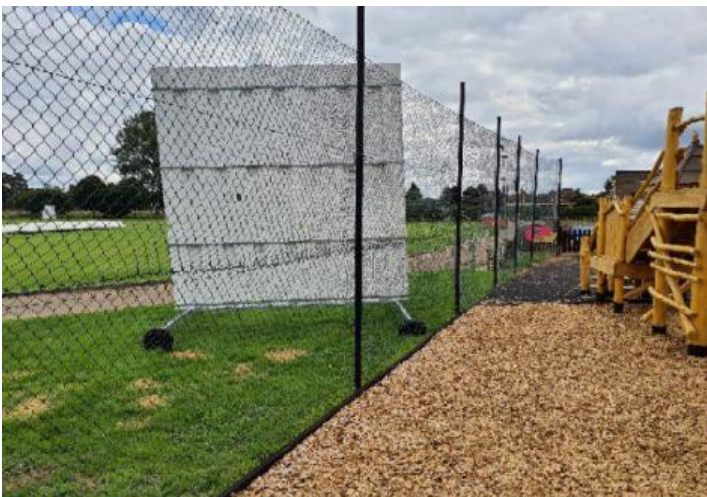
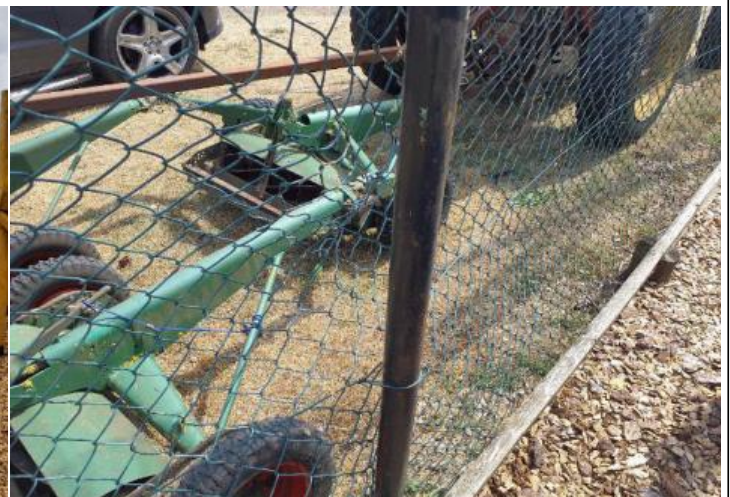
**Item:** Fences - Fence - Chainlink  
**Manufacturer:** Not Identified

**Finding:** The fence is damaged in places

**Action:** Repair or replace all affected sections

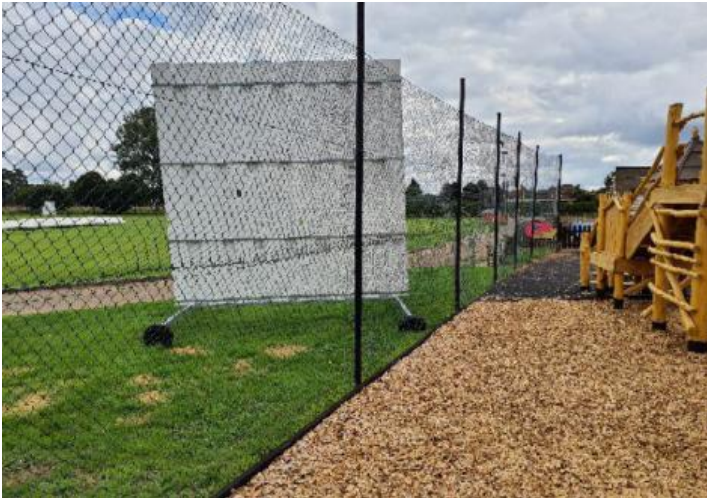
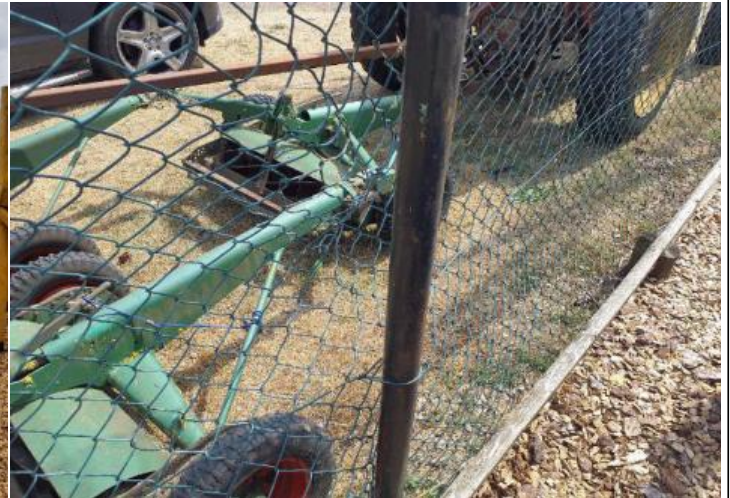
**Item:** Fences - Fence - Chainlink  
**Manufacturer:** Not Identified

**Finding:** The paintwork on this item has been damaged or worn exposing the metal underneath which is rusting

**Action:** Treat any rusting components and repaint

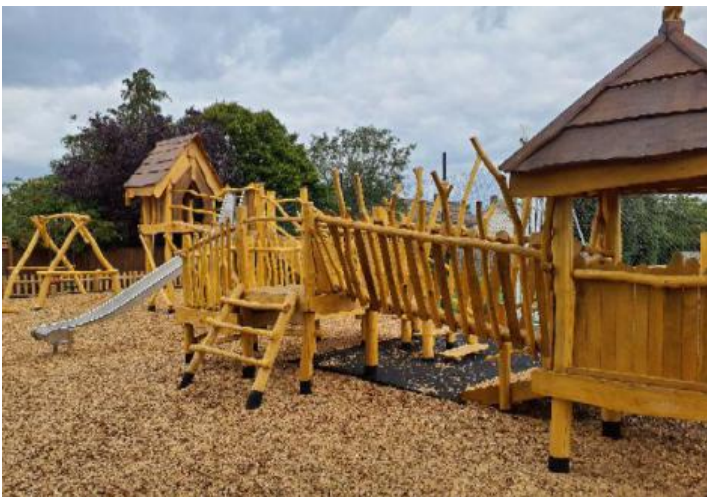
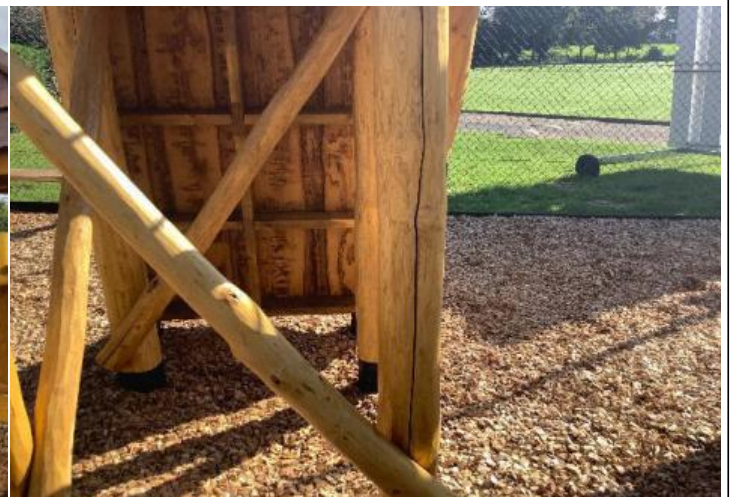
**Item:** Activity Equipment - Multi Play (Senior)  
**Manufacturer:** Not Identified

**Finding:** The timber has a number of splits/shakes or air cracks and this may affect the stability or allow water ingress which will accelerate the rotting process

**Action:** Monitor to ensure the splits do not cross through fixing points of the structure and/or cause any instability
