## Tuddenham Village Council

Inspection Ref: 2282700

Operational Inspection - 2-February-2024 - 13:24 Inspector Philip Smith

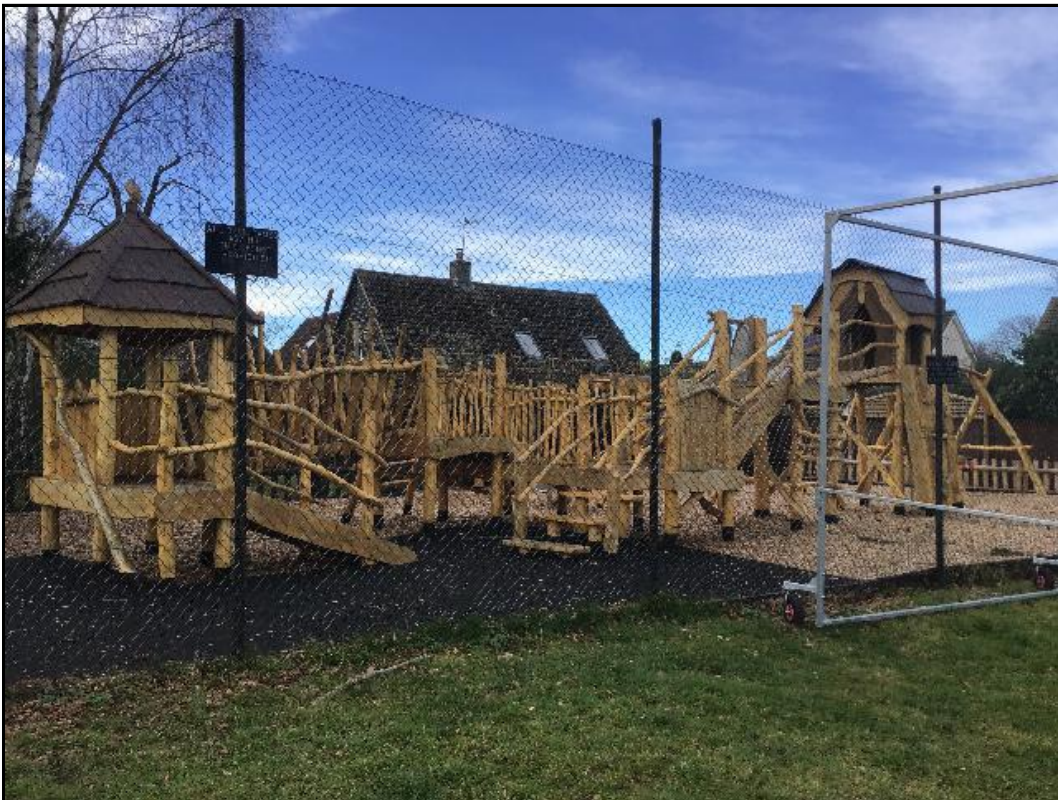
The site is located in an area of public open space and is not directly overlooked by any properties in the local community.

Some accessible features; an area that presents difficulties to the majority of people with disabilities but in favourable circumstances and certainly in partnership can be accessed.
